UNDERWATER FACILITIES
INSPECTION AND ASSESSMENT
AT MAGNETIC SILENCING FACILITY
NAVAL SUBMARINE BASE
TRIDENT SUPPORT SITE
BANGOR, Washington
FPO-1-80 (13)

UNDERWATER FACILITIES INSPECTIONS & ASSESSMENTS

OCEAN ENGINEERING AND CONSTRUCTION PROJECT OFFICE
CHESAPEAKE DIVISION
NAVAL FACILITIES ENGINEERING COMMAND
WASHINGTON, D.C. 20374

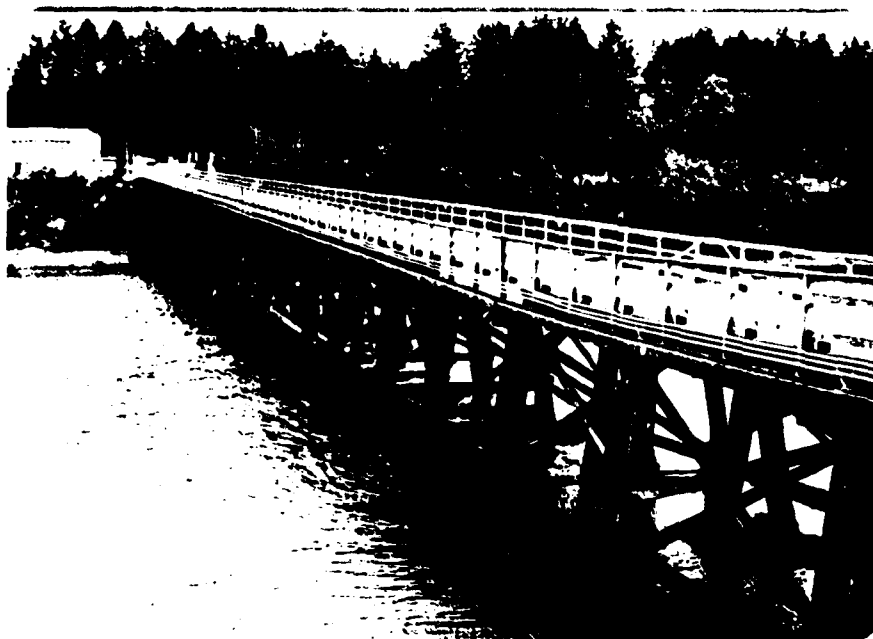
PHOTOGRAPH 2

Access Trestle at the Deperming Pier, Magnetic Silencing Facility, Bangor, Washington.

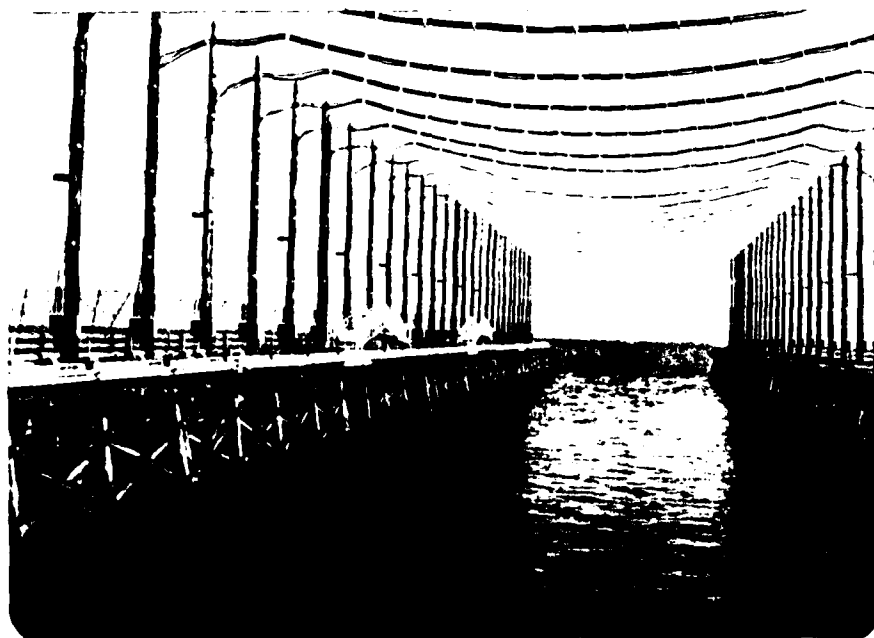
PHOTOGRAPH 3

East and West Piers of the Deperming Pier - looking north.

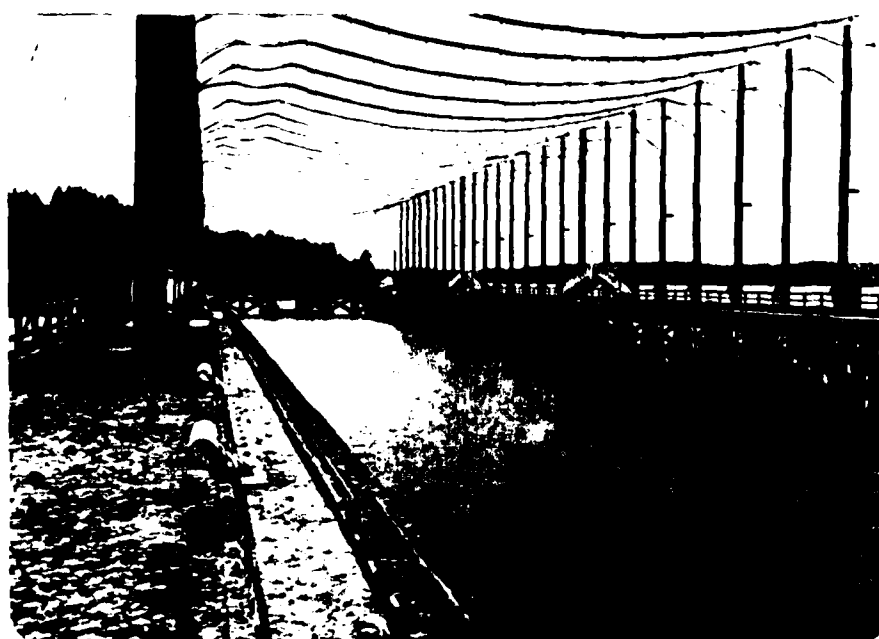
PHOTOGRAPH 4

East and West Piers of the Deperming Pier - looking south towards the Header Pier.

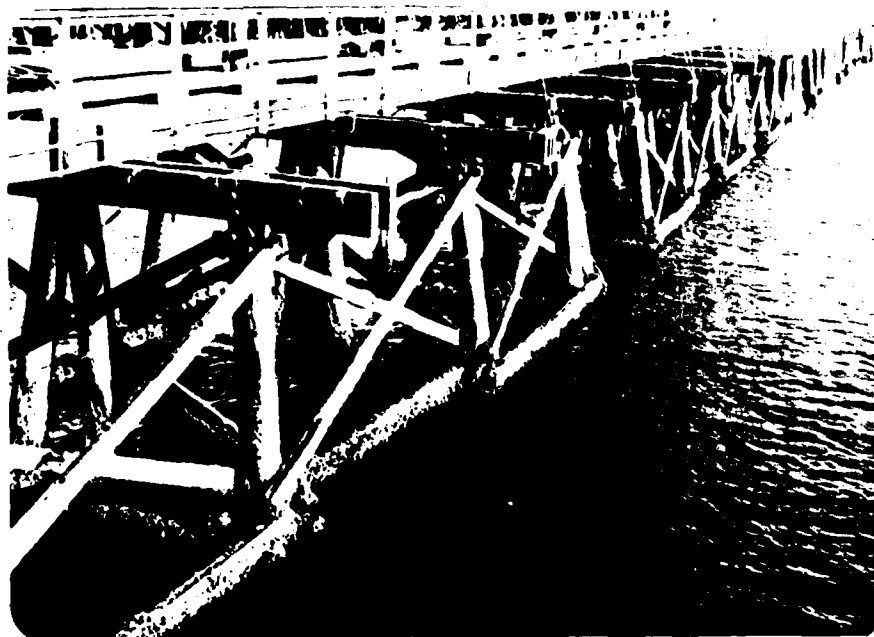
PHOTOGRAPH 5

Extensive timber bracing extends down 12 feet from the pile tops. The Commercial Grade, No. 2, Douglas Fir-Larch bracing extends both with the rows and the bents. (See Photograph 5.)

Typical timber brace framing of piling in the Deperming Pier.

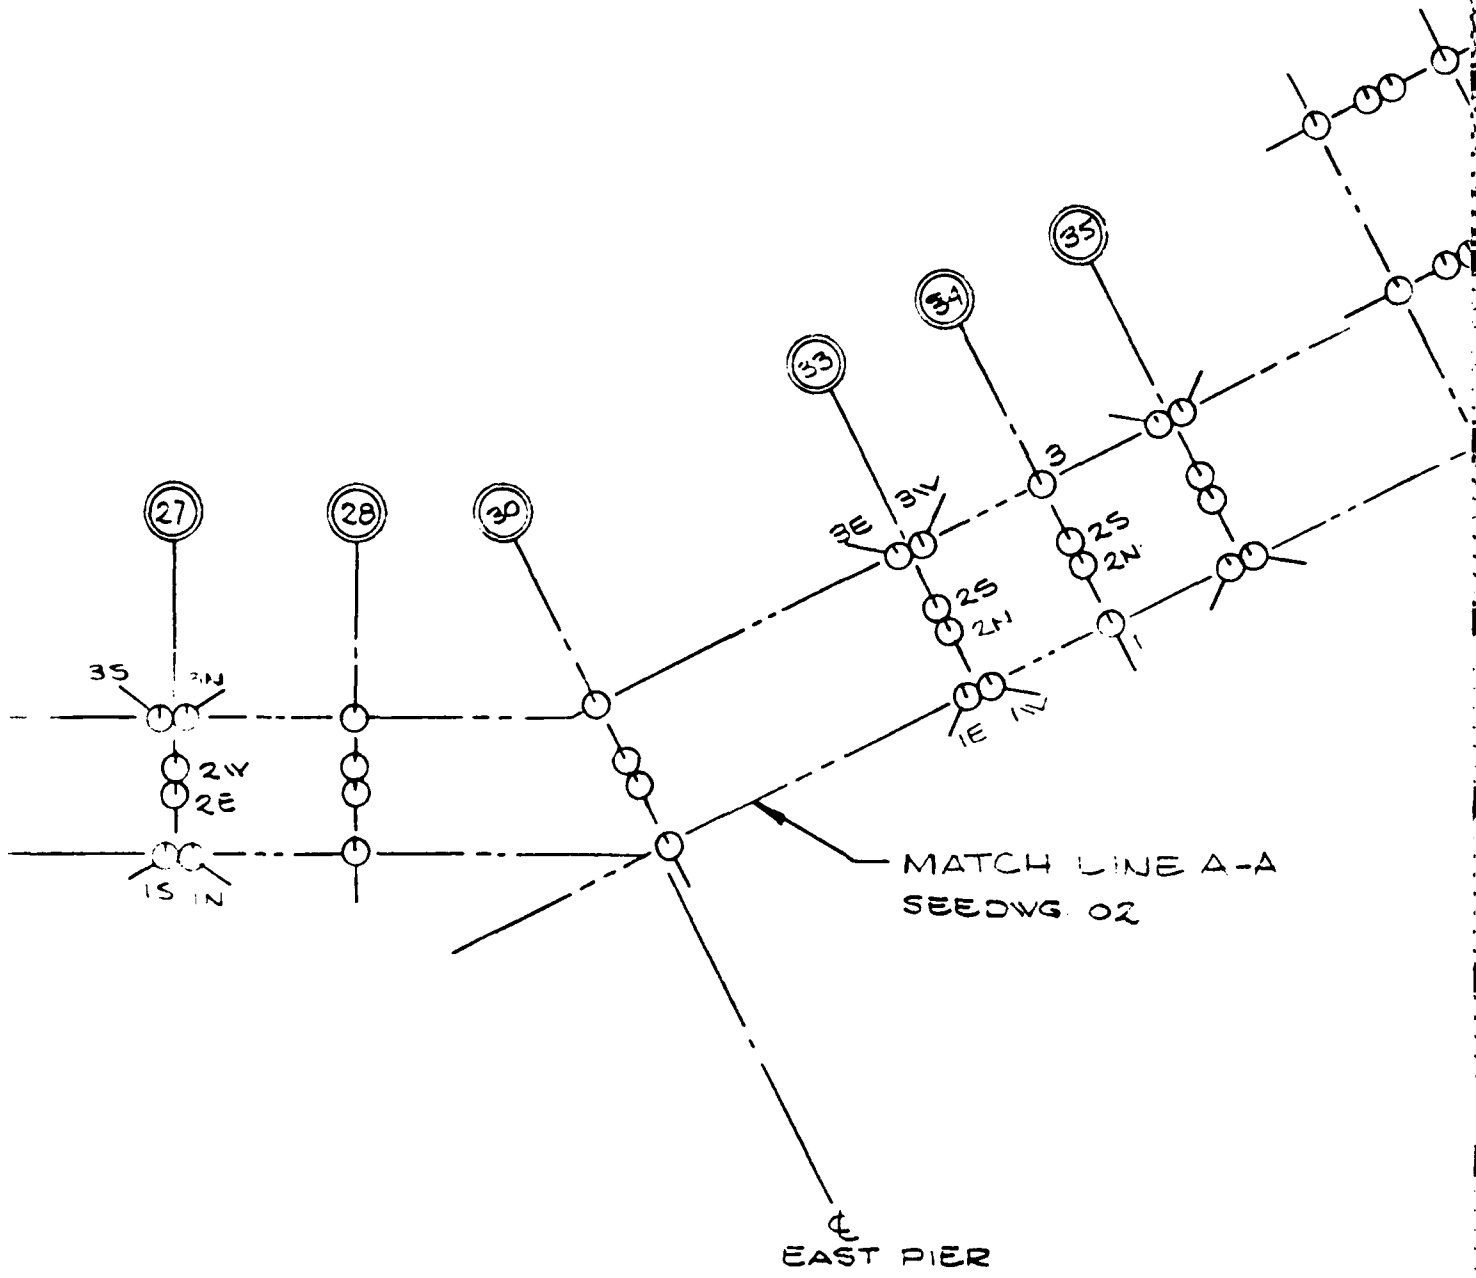
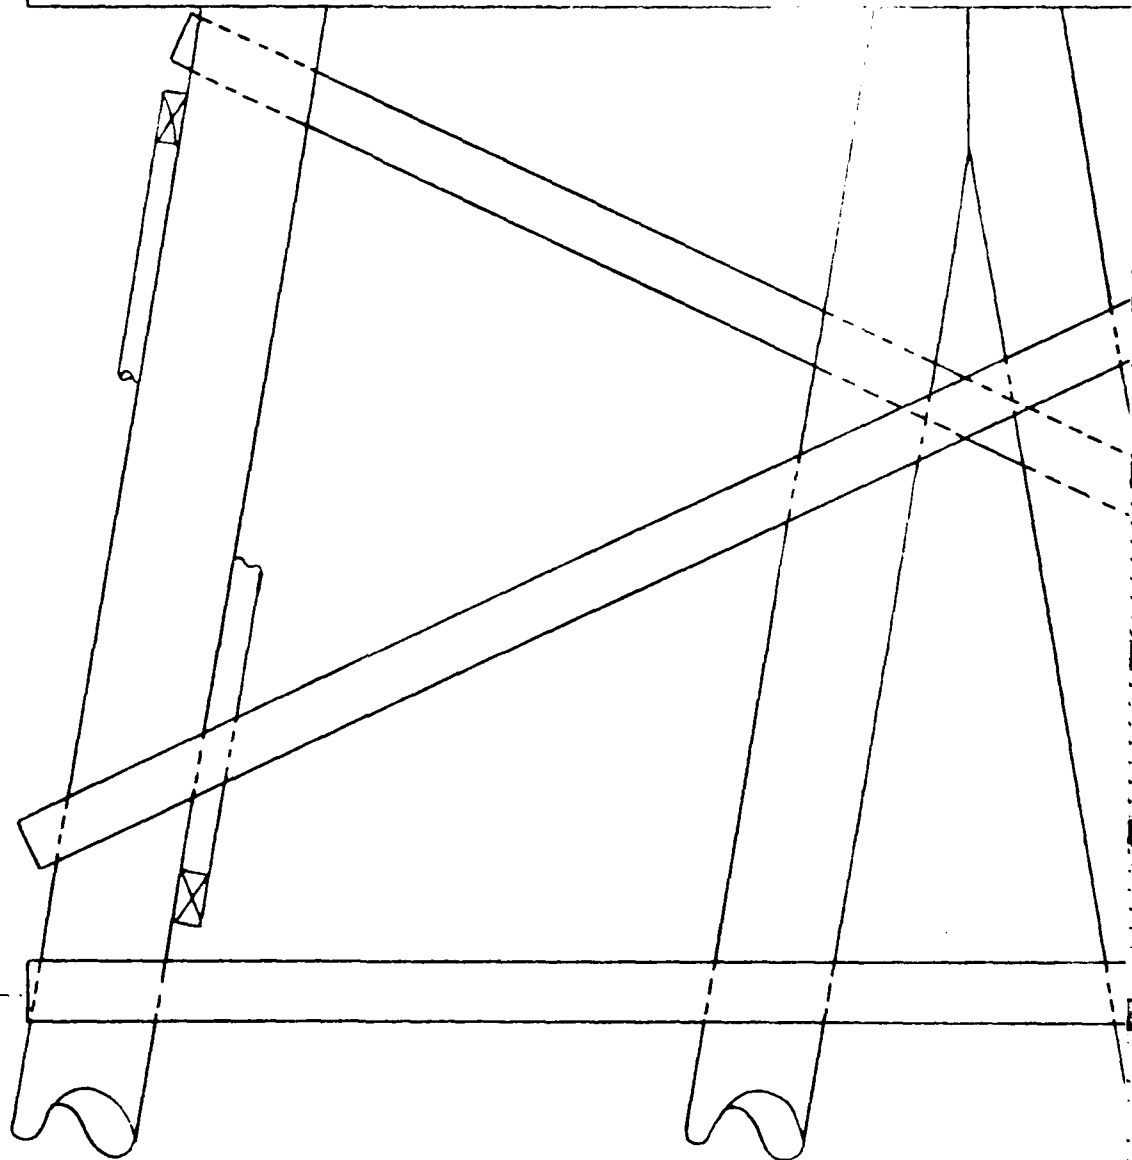
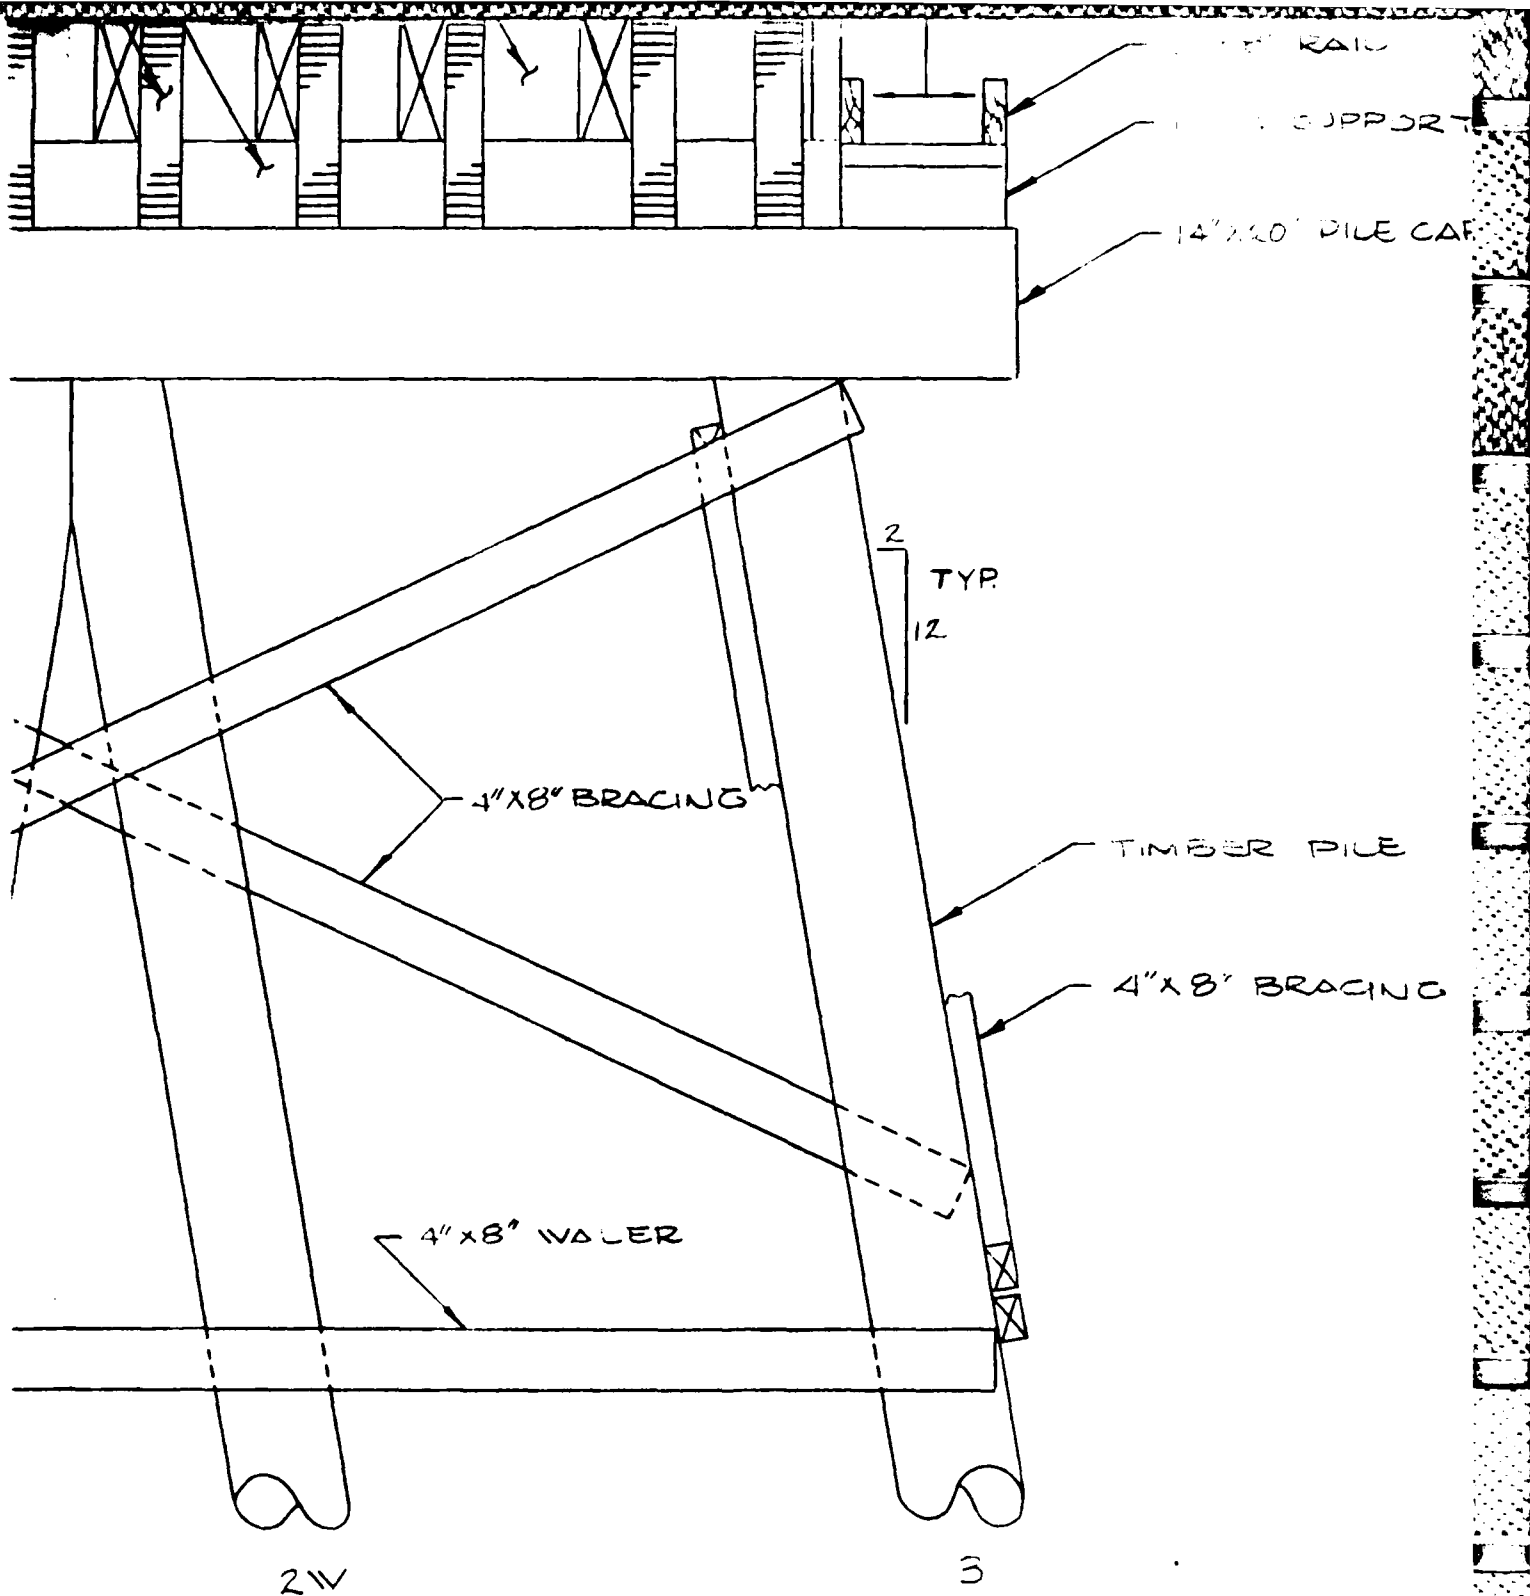
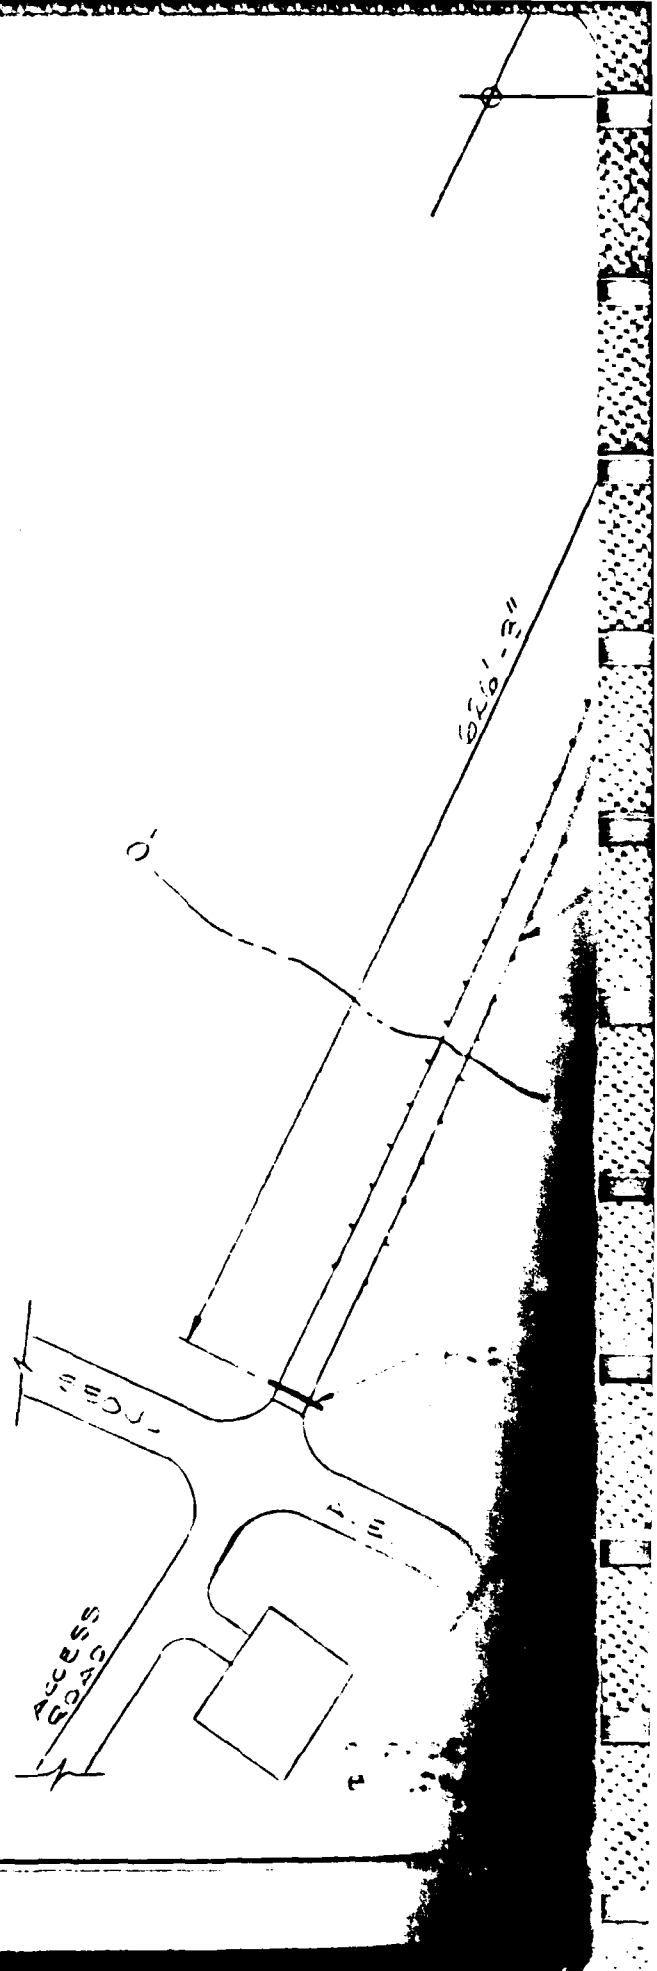
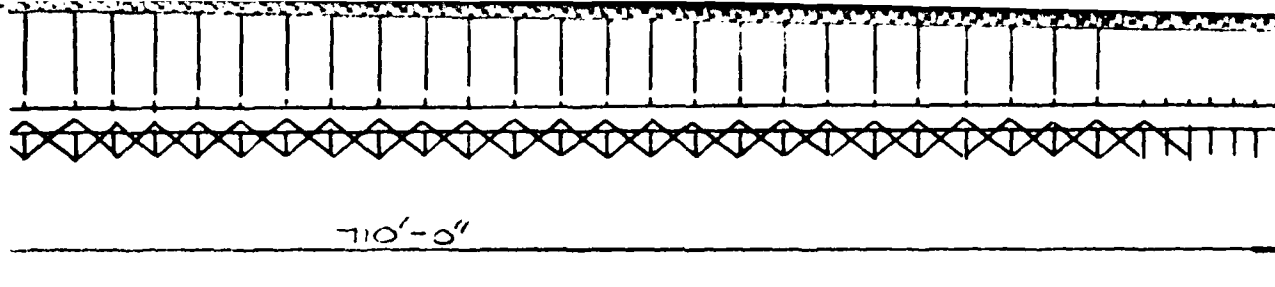
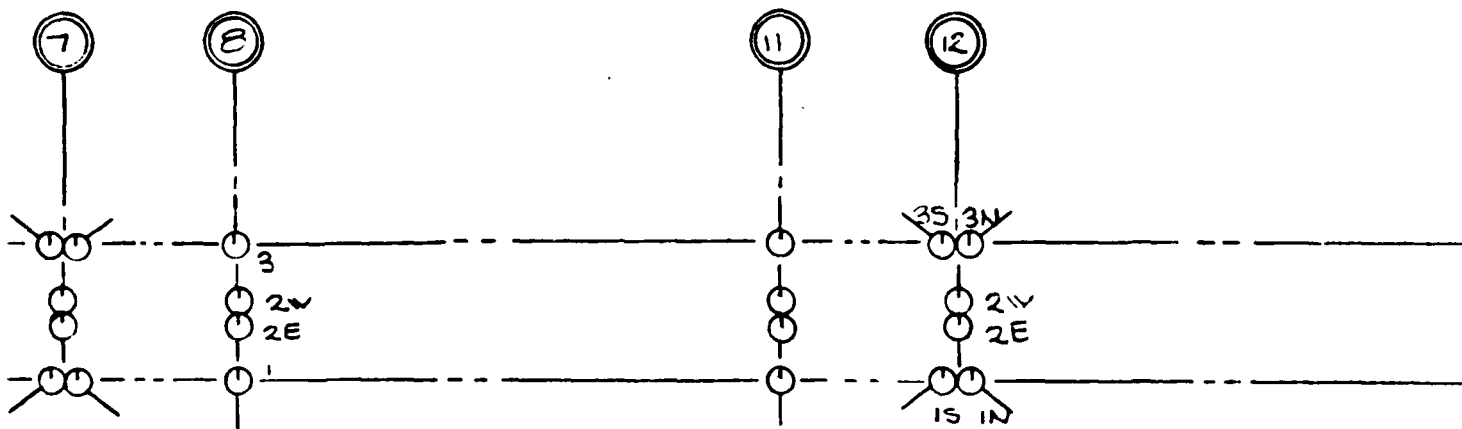
SITE PLAN, ACCESS TRESTLE PLAN
SECTION SHOWING LOCATION AND
CONDITION OF INSPECTED PILING
BRACE CONFIGURATION IN MAGNE
SILENCING FACILITY

Pile 51-2E broken at mudline and infested by marine borers. This pile will require repair or replacement. Piles 77W-3N and 77W-3S broken at -27'. These piles will require repair or replacement. (At this writing, repairs are being implemented.)

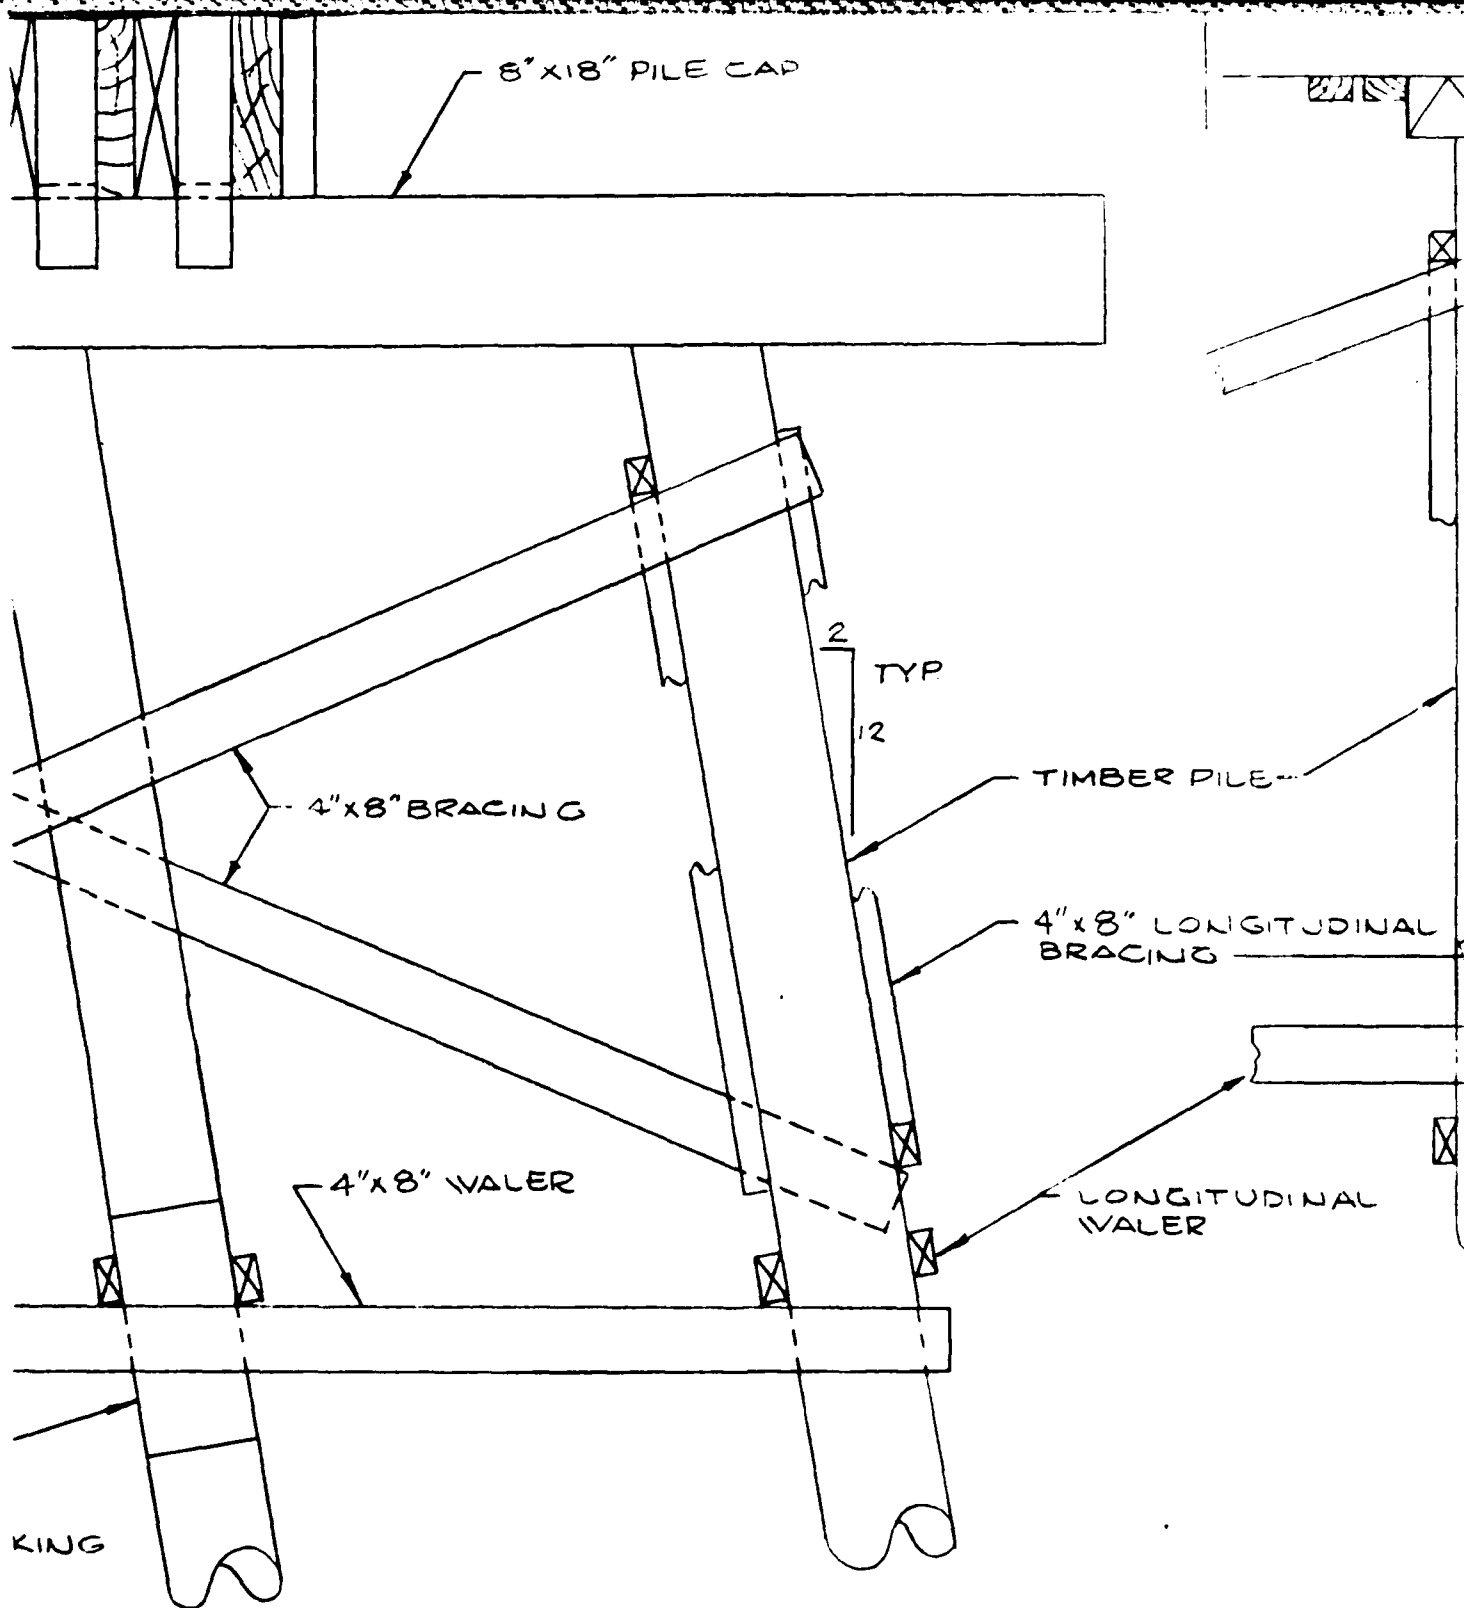
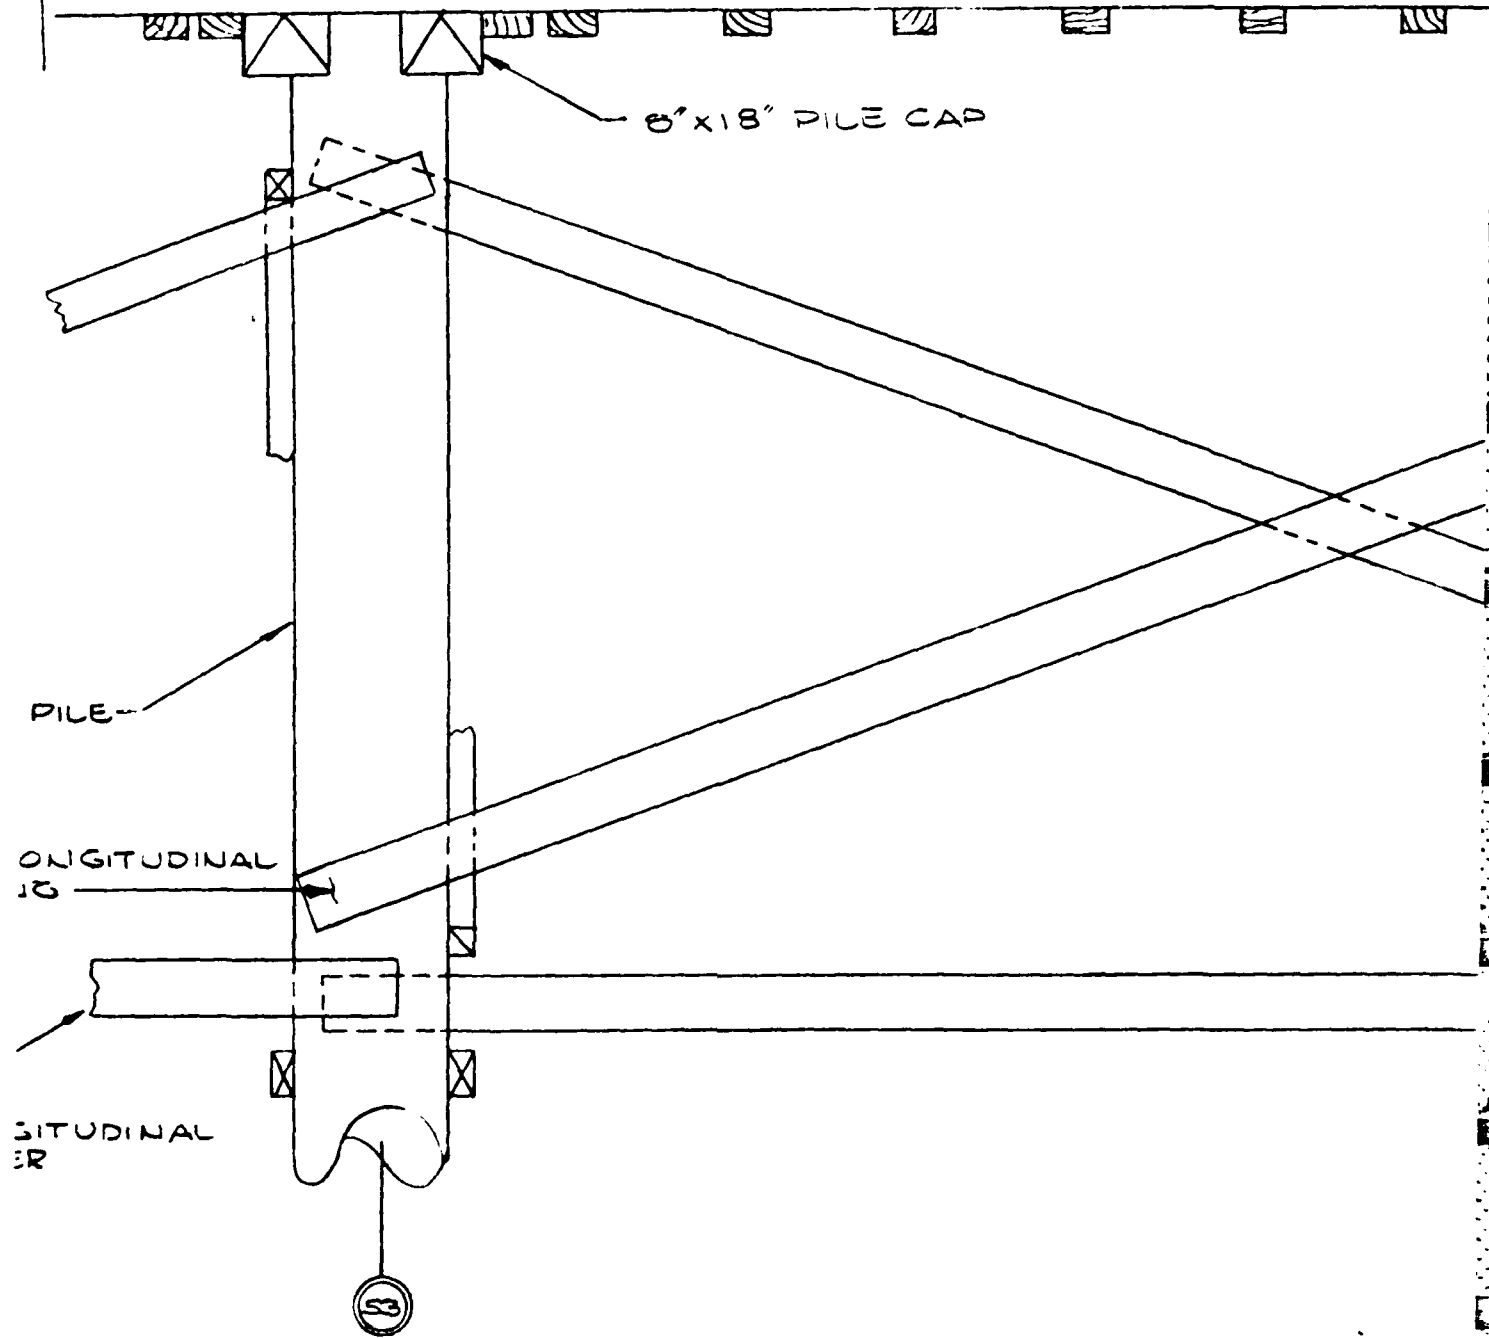
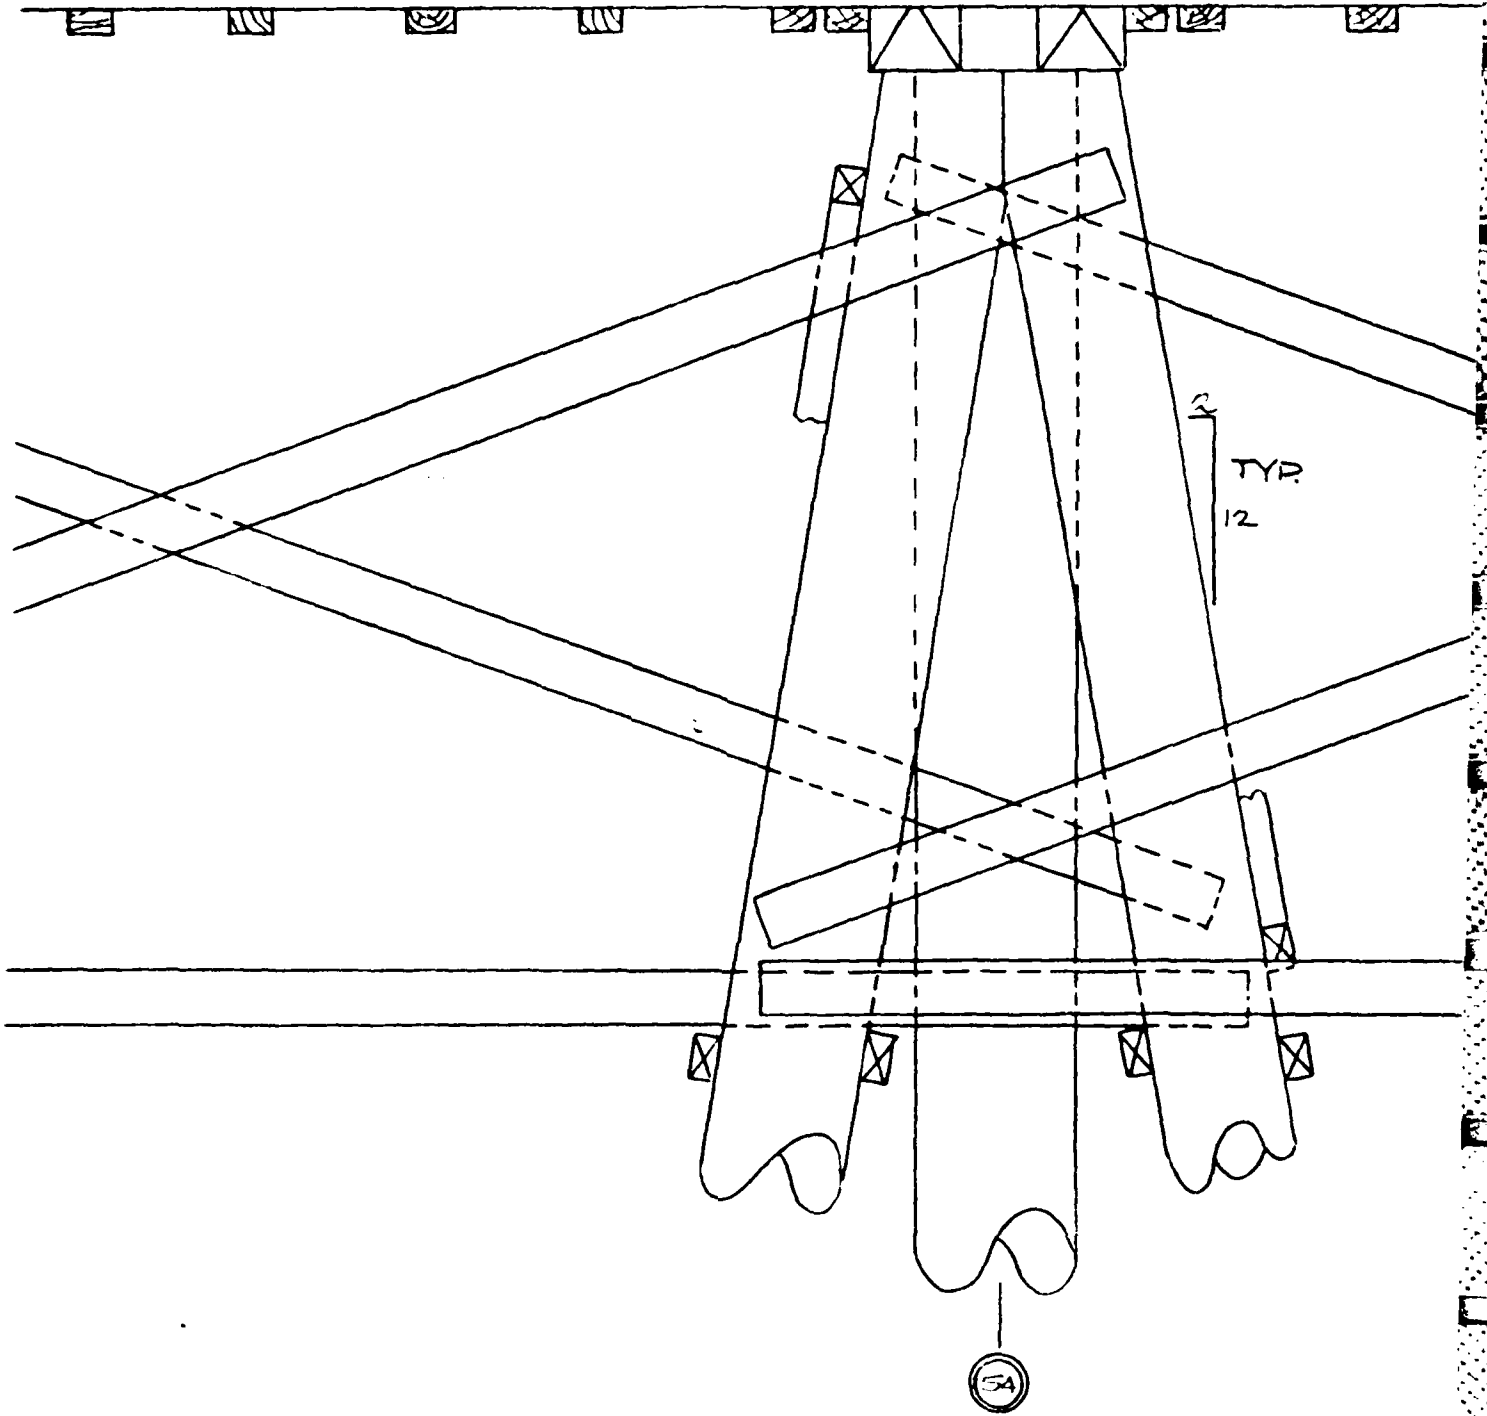
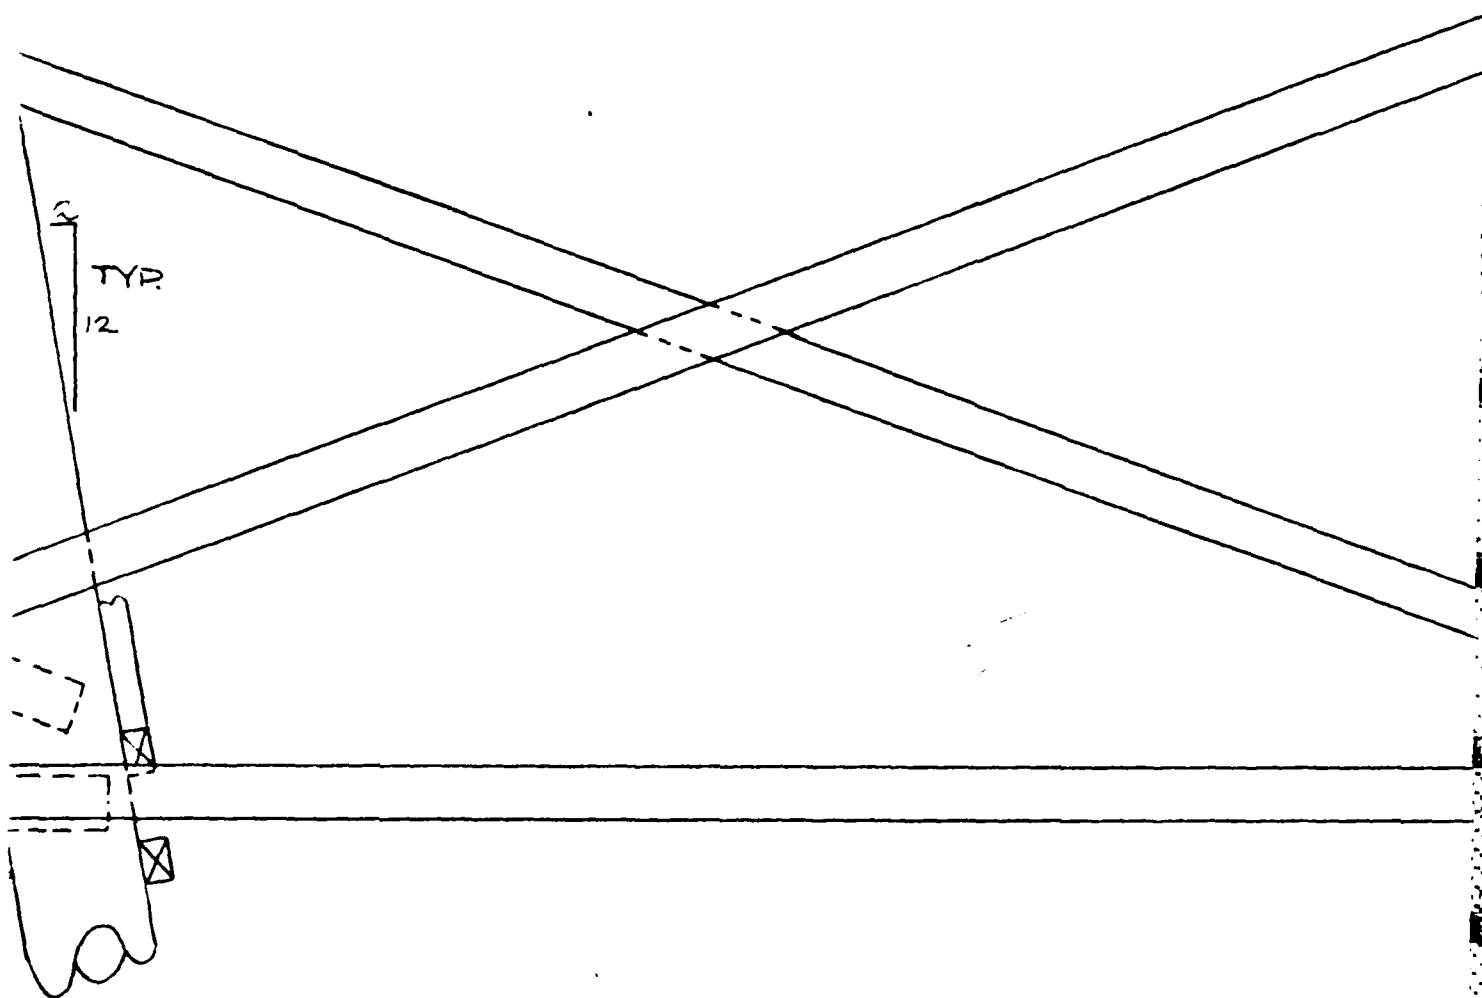
DRAWING-02

PILING PLAN AND ELEVATIONS SHOWING
LOCATION AND CONDITION OF INSPECTED
EAST AND WEST PIER PILING, AND BRACE
CONFIGURATION.

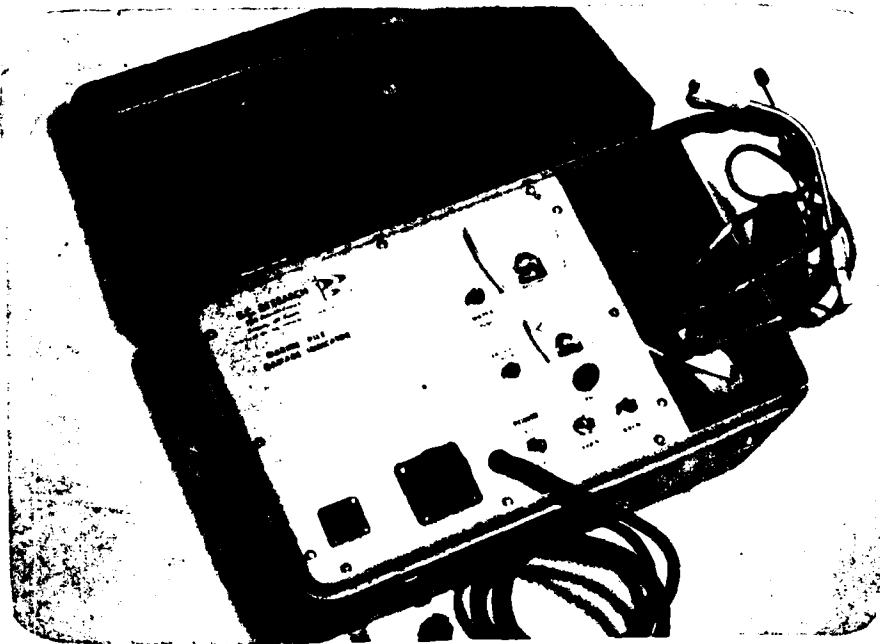
PHOTOGRAPH 21

The surface unit monitored by technician. The meter provides a continuous cross-sectional area readout -- also two-way telephone contact between diver and surface.

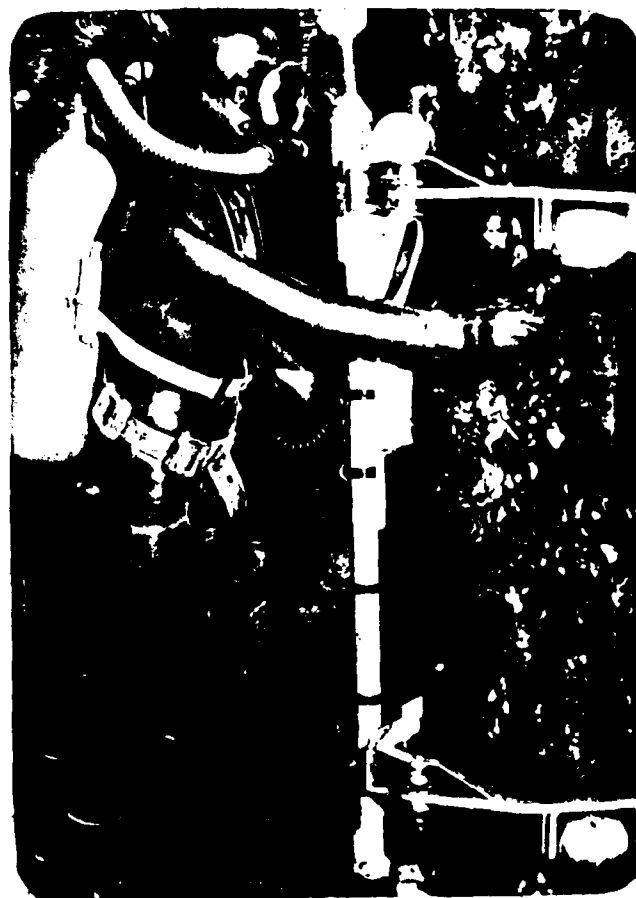
PHOTOGRAPH 22

The ULTRASCAN - PTM4, the underwater sonic probe unit used to scan piles and locate internal damage. Probe is manipulated by diver.

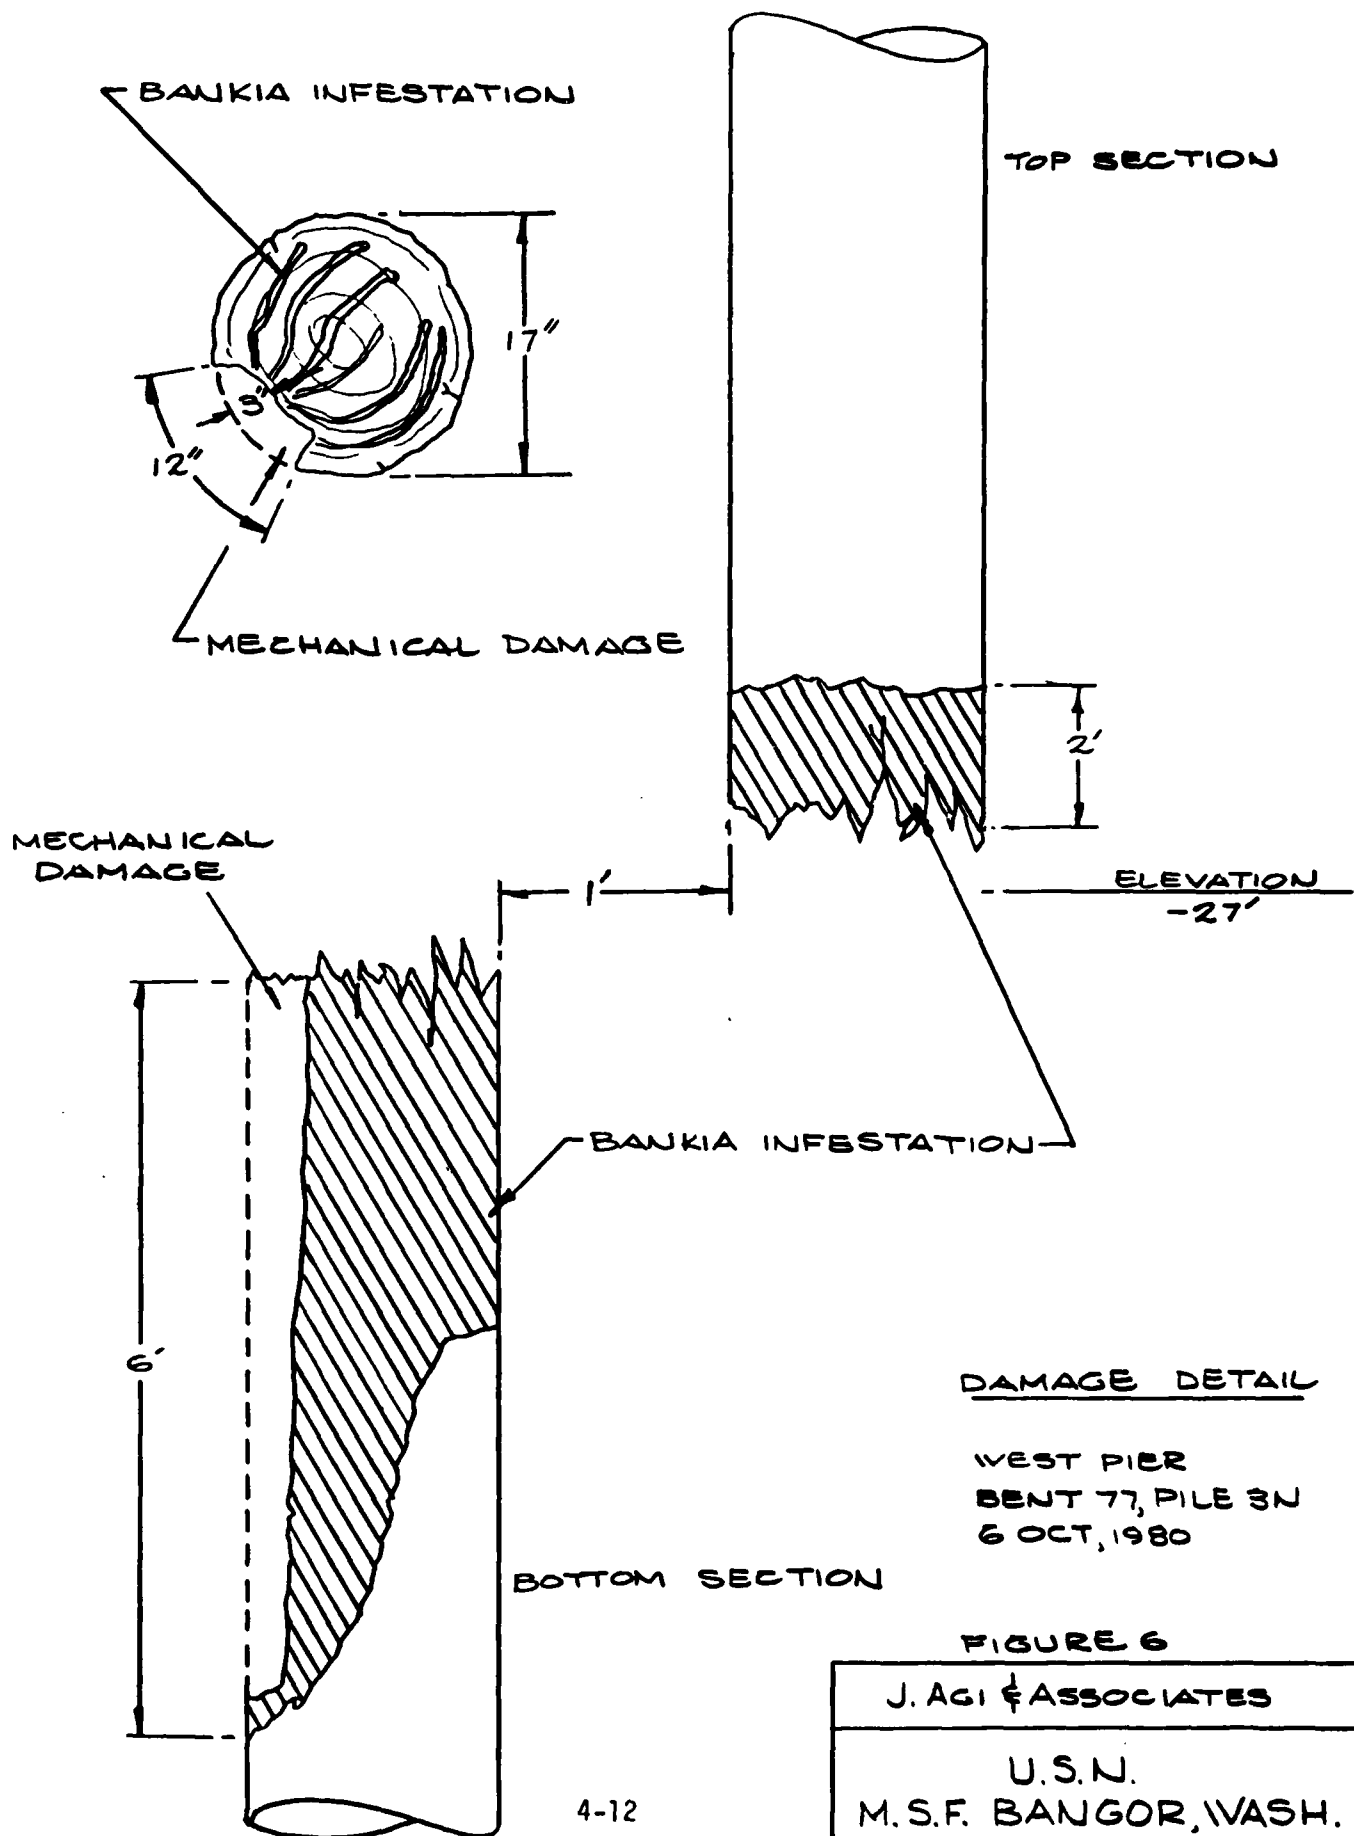
DAMAGE DETAIL

The pile stubs have sustained heavy Bankia setacea attack and damage. Active live Bankia were found in the damaged pile stubs (see Photographs 15, 16 and 19). In some cases the borers had reached $\frac{1}{2}$ " in diameter and a length of 8-10". The 77W-3N pile, bottom stub, had sustained Bankia infestation down at least 6-7 feet from the break. The other pile stubs have also sustained borer attack through the exposed untreated areas of the piles.

Pile 51W-3E is broken at the mudline with marine borer (Bankia) attack at the area of rupture. This pile may have hit a rock below the mudline which resulted in "brooming" at the mudline during driving (see Figure 8).

The overall condition of the examined marine piling was excellent. This situation is consistent with expectations for a properly treated and constructed facility of this age. Nevertheless, the facility is in an area of very heavy marine borer activity as shown by extensive monitoring data and substantiated by the Bankia attack found in piles 77W-3N and 77W-3S, 51W-2E and the untreated timbers. (Figures 6, 7 and 8).

Removal of the damaged pile is recommended if driving of a replacement pile is anticipated. Removal of derelict piles facilitates the placing of replacement piles, facilitates future inspections and removes an immediate source of marine-borer infestation.
